# Baseline Aquatic Assessment: 2017 Nkosi City,

Mpumalanga Province, South Africa

Report Title: **Baseline Aquatic Assessment Report: 2017 Nkosi City, Mpumalanga Province, South Africa.**

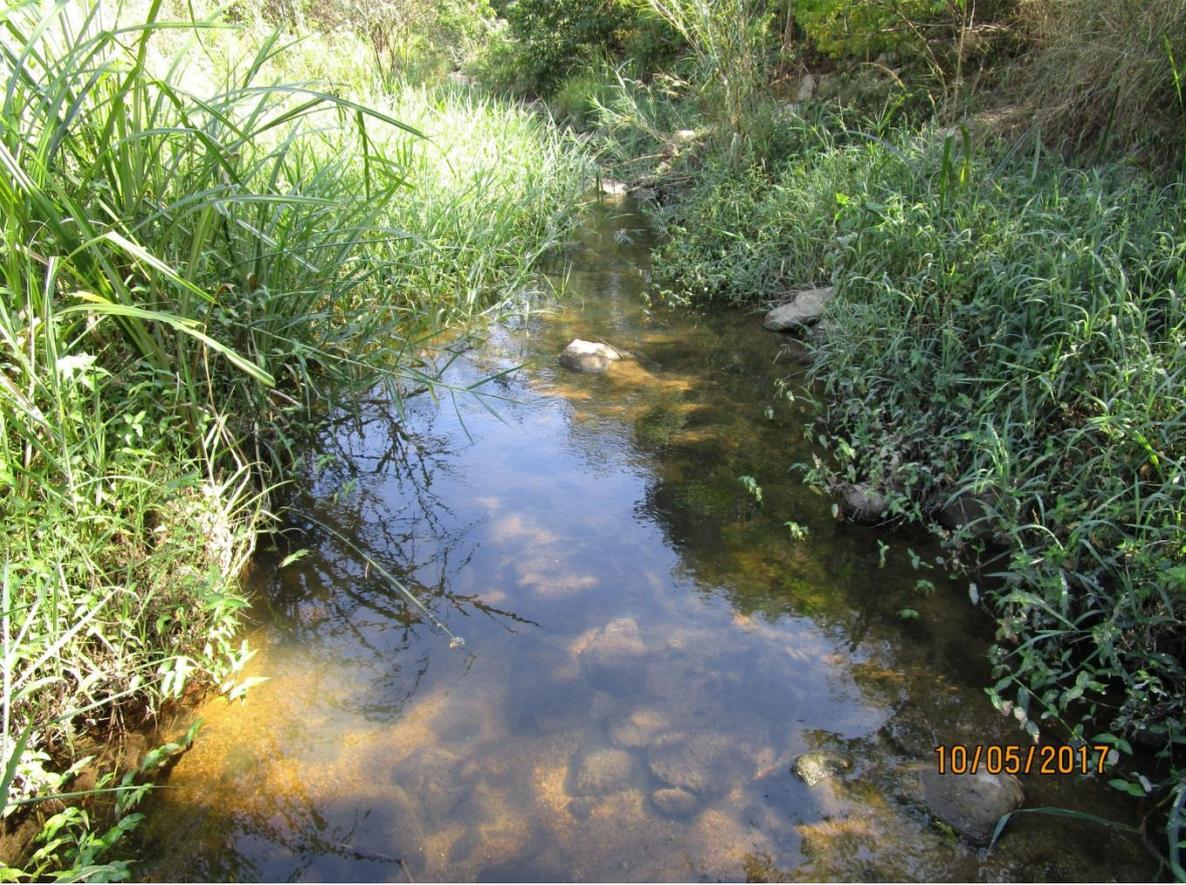
**Table 4: Overview of conditions observed at downstream site NK6**

GEOMORPHOLOGICAL ZONE	VEGETATION	QUATERNARY CATCHMENT
Lower	Pretoriuskop Mountain Bushveld	X24C

INDICATOR	DESCRIPTION										
<b>PHYSICO-CHEMICAL DRIVERS</b>											
<b>IN SITU WATER QUALITY</b>	The visual appearance of the water prior to sampling was clear. The <i>in situ</i> chemical parameters measured ( <b>Annexure B</b> ) were within the TWQRs for aquatic ecosystems with the exception of DO. Do levels at NK6 were in excess of 100%. This is super saturated and can be indicative of eutrophication. The pH at the site was also slightly elevated (8.50 and 8.59) indicating a more alkaline environment.										
<b>HABITAT</b>	The flow was moderate. Habitats could be affected by trampling from livestock. Habitat consists of large boulders, small cobbles and GSM, whilst a small amount of bedrock is present. Dense vegetation surrounds the site. <b>Annexure C</b> contains the IHAS Score Sheets. The IHAS score was 85, which indicates a habitat that is highly sufficient for supporting a diverse macroinvertebrate community.										
<b>SPECIES RESPONSE</b>											
<b>INVERTEBRATES</b>	<p>The SASS5 evaluation sheets are contained in <b>Annexure D</b>. The SASS5 results obtained during this survey can be summarised as follows:</p>

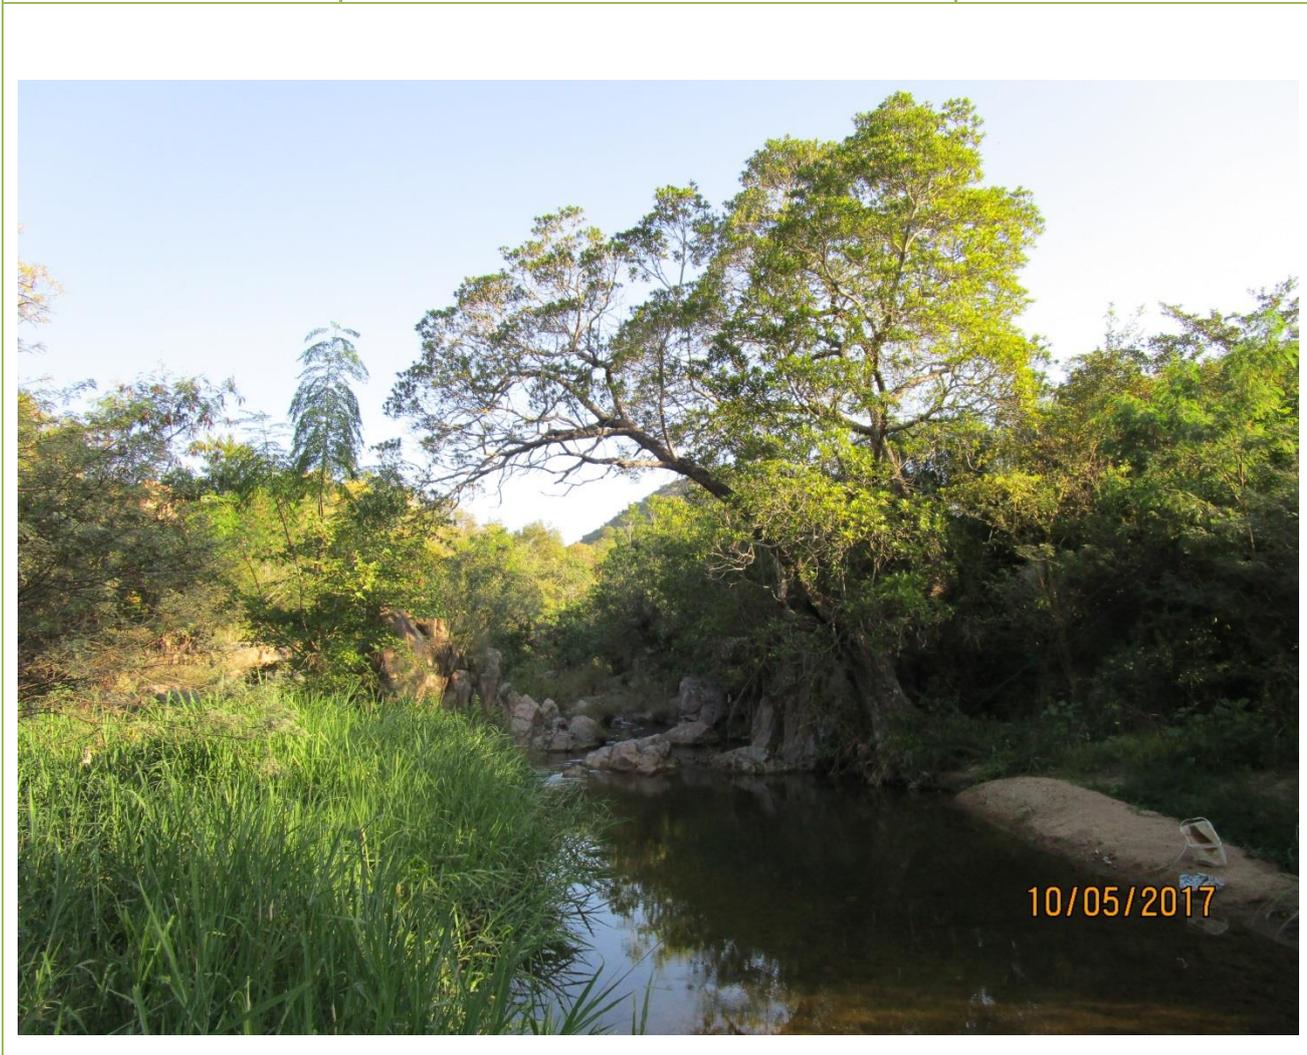
**Table 6: Overview of conditions observed at downstream site NK7**

GEOMORPHOLOGICAL ZONE	VEGETATION	QUATERNARY CATCHMENT
Lower	Malelane Mountain Bushveld	X24C

INDICATOR	DESCRIPTION										
<b>PHYSICO-CHEMICAL DRIVERS</b>											
<b>IN SITU WATER QUALITY</b>	The visual appearance of the water prior to sampling was clear and flow was high but probability of artificial flow is high due to WWTW upstream. The <i>in situ</i> chemical parameters measured ( <b>Annexure B</b> ) were all within the TWQR's for aquatic ecosystems. DO levels at NK7 were in excess of 100%. This is super saturated and can be indicative of eutrophication.										
<b>HABITAT</b>	The flow is moderate. Habitat consists largely of GSM, as well as some large and small stones and bedrock. A large amount of fringing vegetation is present. <b>Annexure C</b> contains the IHAS Score Sheets. The IHAS score was 85, which indicates a habitat that is highly suitable for supporting a diverse macroinvertebrate community.										
<b>SPECIES RESPONSE</b>											
<b>INVERTEBRATES</b>	<p>The SASS5 evaluation sheets are contained in <b>Annexure D</b>. The SASS5 results obtained during this survey can be summarised as follows:</p>

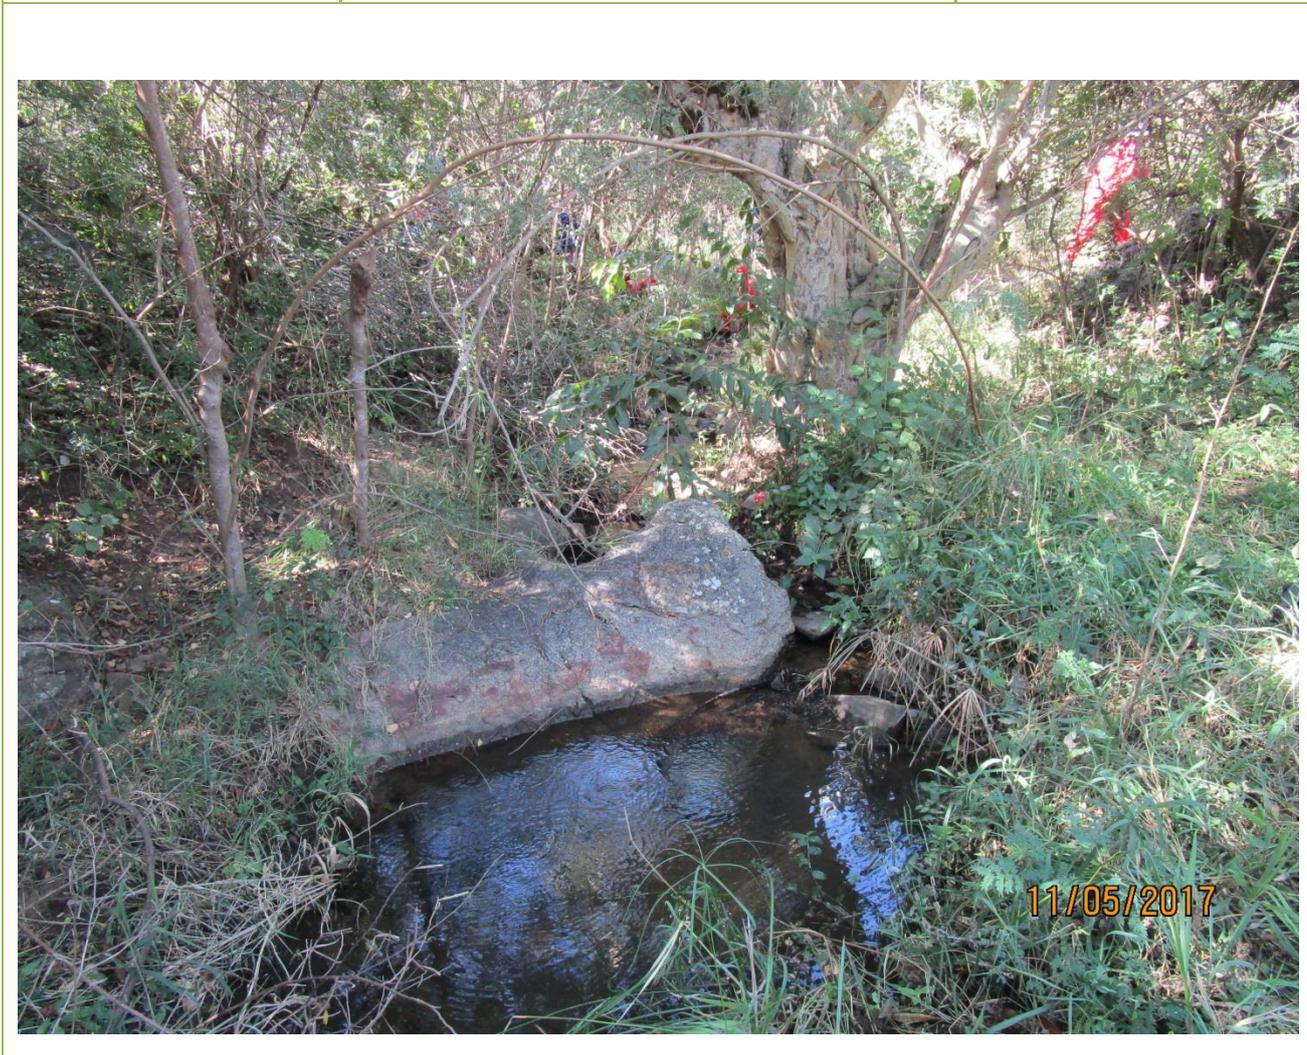
**Table 8: Overview of conditions observed at upstream site NK8**

GEOMORPHOLOGICAL ZONE	VEGETATION	QUATERNARY CATCHMENT
Lower	Malelane Mountain Bushveld	X24C

INDICATOR	DESCRIPTION										
<b>PHYSICO-CHEMICAL DRIVERS</b>											
<b>IN SITU WATER QUALITY</b>	The visual appearance of the water prior to sampling was clear. The <i>in situ</i> chemical parameters measured ( <b>Annexure B</b> ) were all within the TWQR's for aquatic ecosystems.										
<b>HABITAT</b>	The flow was low at this site. Habitat consisted mostly of large boulders, with some GSM, small cobbles and bedrock was present. Marginal vegetation was limited at this site due to low flow levels. <b>Annexure C</b> contains the IHAS Score Sheets. The IHAS score was 73, which indicates a habitat that is acceptable for supporting a diverse macroinvertebrate community.										
<b>SPECIES RESPONSE</b>											
<b>INVERTEBRATES</b>	<p>The SASS5 evaluation sheets are contained in <b>Annexure D</b>. The SASS5 results obtained during this survey can be summarised as follows:</p>

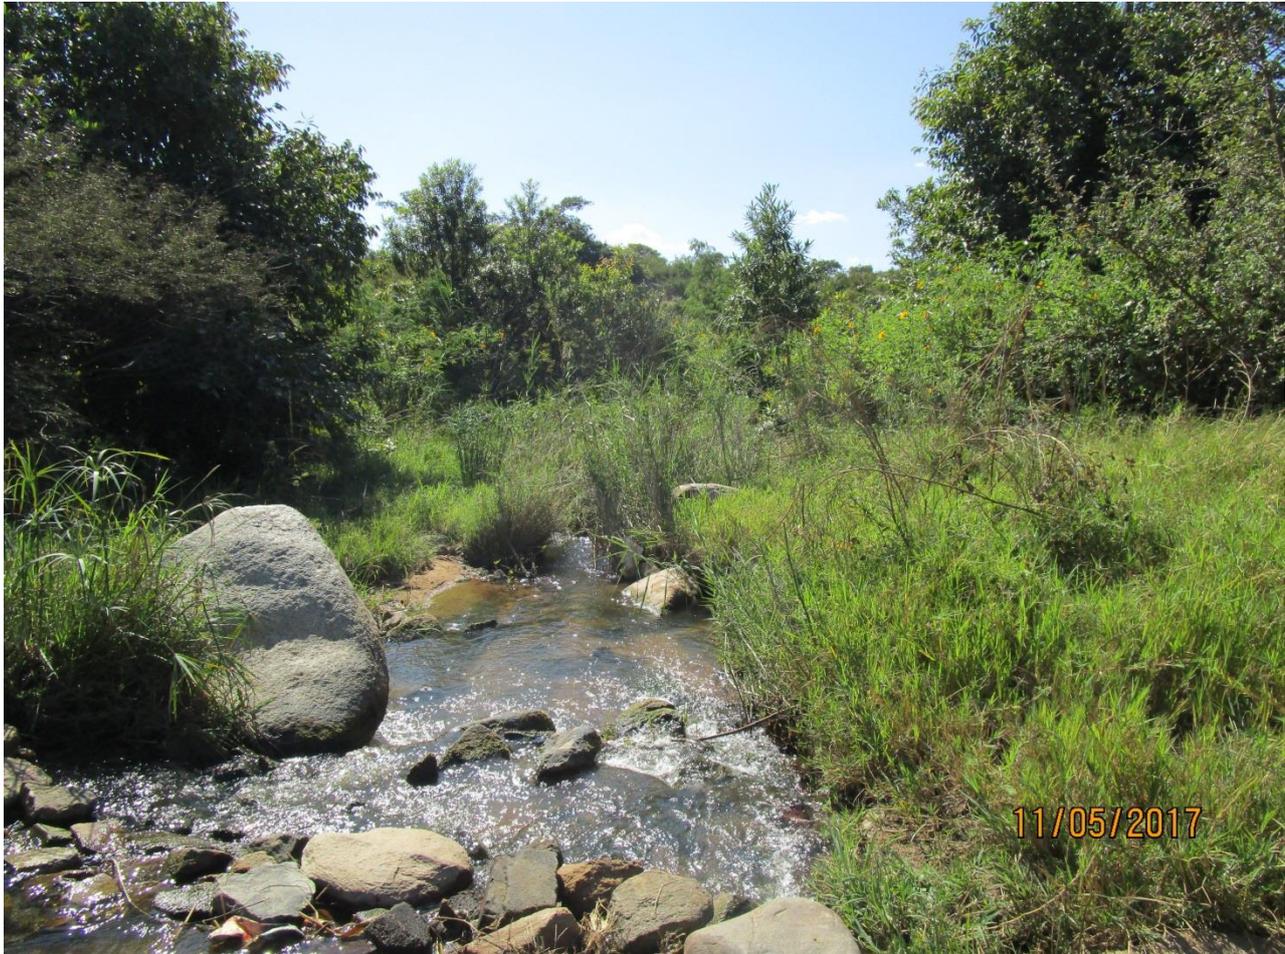
**Table 10: Overview of conditions observed at upstream site NK9**

GEOMORPHOLOGICAL ZONE	VEGETATION	QUATERNARY CATCHMENT
Lower	Malelane Mountain Bushveld	X24C

INDICATOR	DESCRIPTION										
<b>PHYSICO-CHEMICAL DRIVERS</b>											
<b>IN SITU WATER QUALITY</b>	The visual appearance of the water prior to sampling was opaque. The <i>in situ</i> chemical parameters measured ( <b>Annexure B</b> ) were all within the TWQR's for aquatic ecosystems.										
<b>HABITAT</b>	The flow was moderate. Habitat consists of GSM and small cobbles, to a lesser extent large boulders and bedrock. <b>Annexure C</b> contains the IHAS Score Sheets. The IHAS score was 76, which indicates a habitat that is highly suitable for supporting a diverse macroinvertebrate community.										
<b>SPECIES RESPONSE</b>											
<b>INVERTEBRATES</b>	<p>The SASS5 evaluation sheets are contained in <b>Annexure D</b>. The SASS5 results obtained during this survey can be summarised as follows:</p>

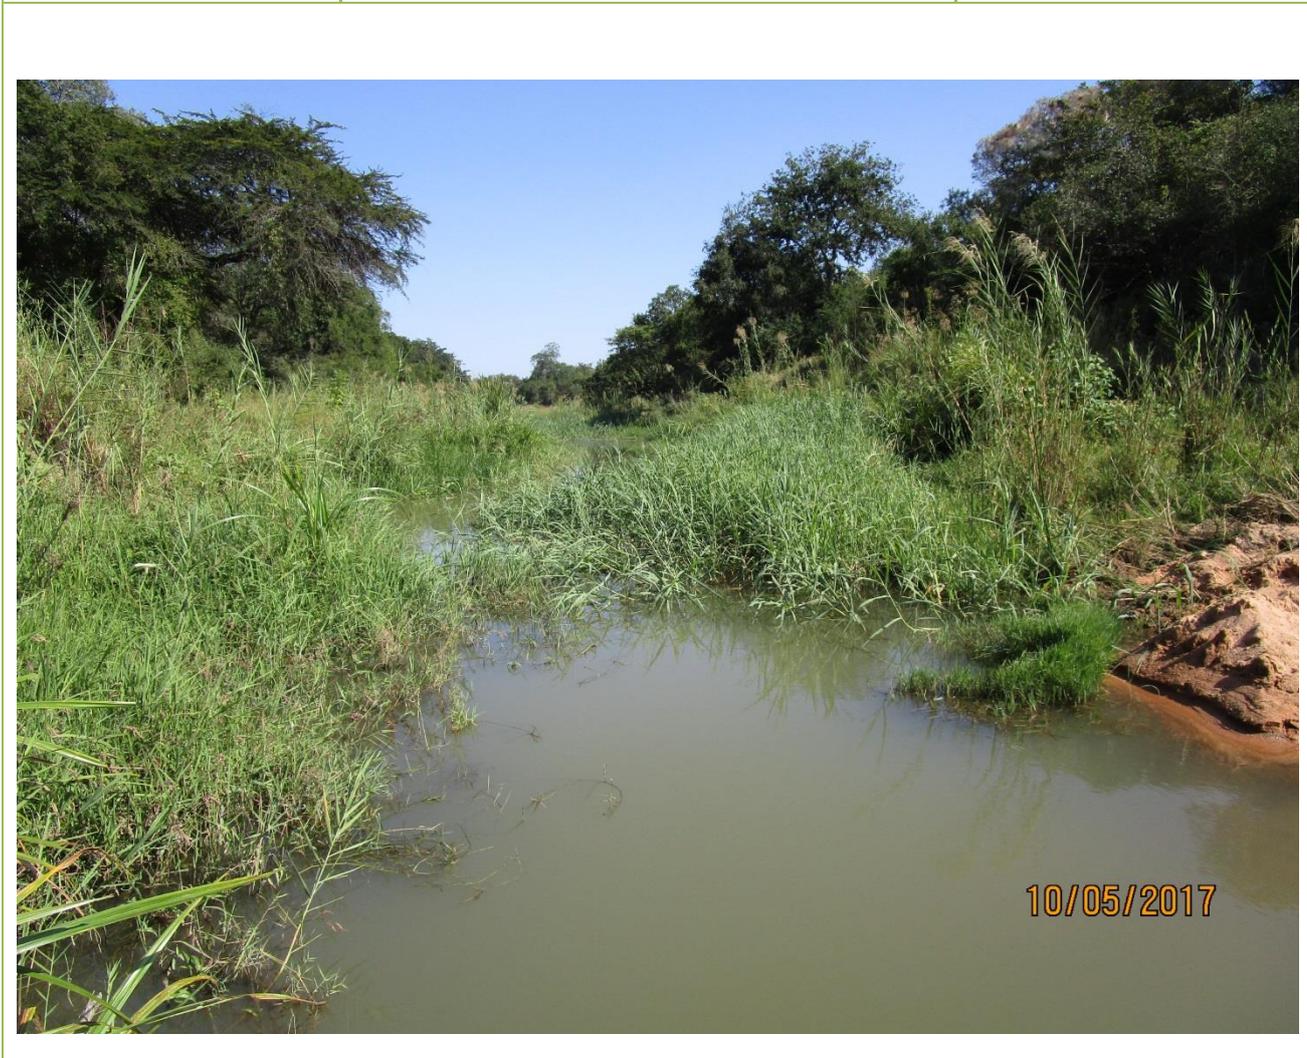
**Table 12: Overview of conditions observed at upstream site NK10**

GEOMORPHOLOGICAL ZONE	VEGETATION	QUATERNARY CATCHMENT
Lower	Pretoriuskop Mountain Bushveld	X24B

INDICATOR	DESCRIPTION										
<b>PHYSICO-CHEMICAL DRIVERS</b>											
<b>IN SITU WATER QUALITY</b>	The visual appearance of the water prior to sampling was opaque. The <i>in situ</i> chemical parameters measured ( <b>Annexure B</b> ) were all within the TWQR's for aquatic ecosystems, with the exception of DO levels. DO levels at NK10 were below TWQRs for aquatic ecosystems but still above sub lethal limits.										
<b>HABITAT</b>	The flow was high. Road crossing was present as well as alien vegetation. Habitat consists of GSM and small cobbles, to a lesser extent large boulders and bedrock. <b>Annexure C</b> contains the IHAS Score Sheets. The IHAS score was 72, which indicates a habitat that is acceptable for supporting a diverse macroinvertebrate community.										
<b>SPECIES RESPONSE</b>											
<b>INVERTEBRATES</b>	<p>The SASS5 evaluation sheets are contained in <b>Annexure D</b>. The SASS5 results obtained during this survey can be summarised as follows:</p>
